## Fault location in the outer sheath of power cables

**Keywords:** Power cable outer sheath, Fault locating, Bridge method, Step voltage method

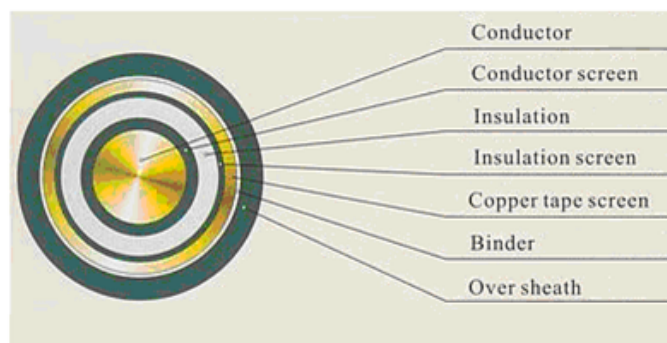
Figure 1: Structure of the single-core cable

Power cables are classified as single core or multi-core, depending on the type of conductor core [11], and the different structures are shown in Fig. 1...4. The power cable consists of a conductor core, a conductor shielding layer, a silicone rubber insulating layer, a silicon rubber insulating and shielding layer, a copper strip shielding layer, a non-woven fabric layer and the outer sheath layer, which varies with the number of cores.

As shown in the figures, the outer sheath is the outermost layer of the cable. As there may be electromagnetic induction when the cable is in use, a comparatively high induced voltage can be generated between the core and the metallic shielding layer of a long, high-voltage cable. To prevent the induced voltage from circulating in the metallic shielding layer [12], the insulating performance of the outer sheath has to be strengthened, and the cable must be

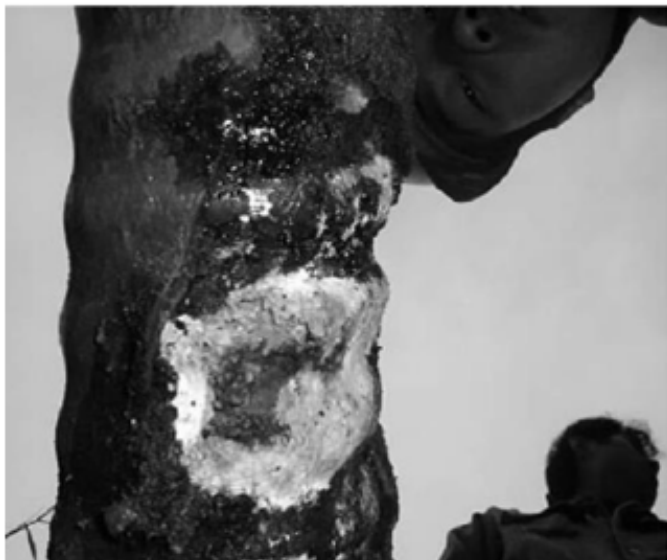
Figure 5: Cables eroded by white ants

4. White ant erosion. In February 2004, the Guangzhou Power Supply Bureau assisted the municipal government with the construction of the Guangzhou Bridge Tunnel. During relocation of the cables from Yangji Station to Jiefang Road, 150 m of cables were recovered, and there were a total of 64 points where they were bitten through by white ants, as shown in Fig. 5.

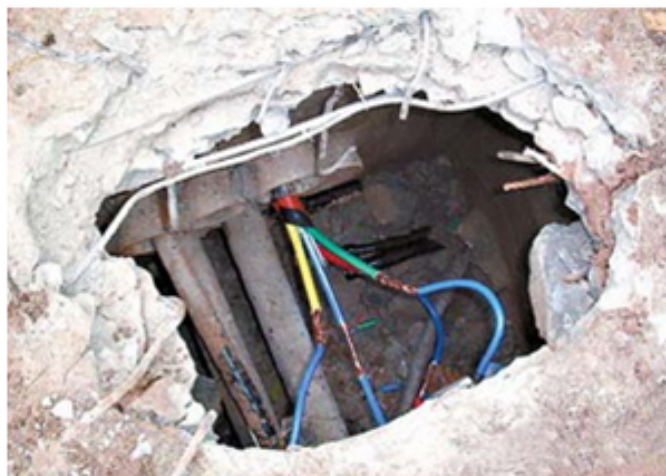
Figure 6: Cables damaged by theft

and theft and attempted theft may cause damage to the cables (Fig. 6).

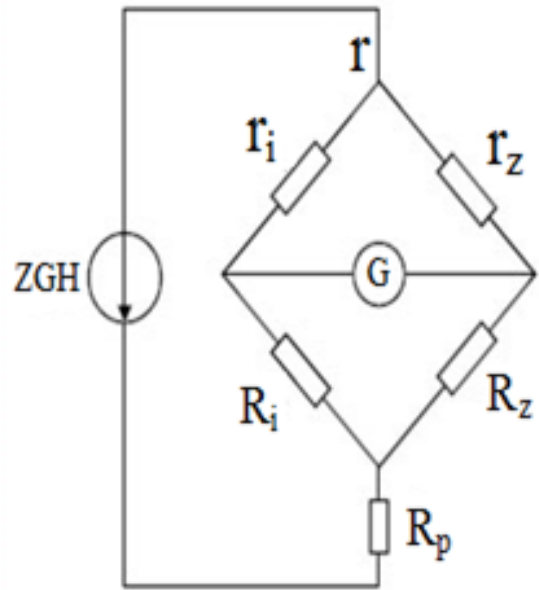
$$\frac{r_i}{r_z} = \frac{R_i}{R_z} = \frac{X}{2L - X} \quad (1)$$

The detection principle of the bridge method—also called the Murray loop bridge—is shown in Fig. 7 and Fig. 8. Phase A and Phase B are connected, the cable resistance is equivalent to  $r_i$ ,  $r_z$ ,  $R_i$  and  $R_z$  in the bridge, and the resistance to ground of the fault point is equivalent to  $R_p$ . When the bridge balance is achieved, Formula (1) can be used to determine the location of the fault point. However, the insulating resistance of the fault point may vary with humidity and temperature, as well as with the damage to, and the materials of, the outer sheath. In addition, this method can be affected by various external factors [12], which is why it can only be used for "rough" location.

Figure 8: Detection principle of the bridge method

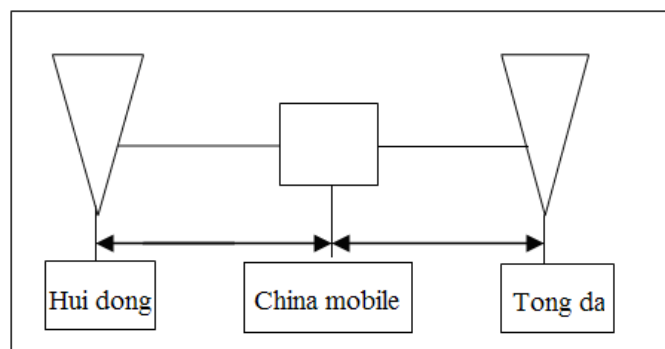
Figure 10: Schematic diagram of the 110 kV extra-high-voltage power cable line in Zigong (Shuhui Line)

1. Rated voltage of the cable: 64/110 kV (Fig. 10).
2. Cable model: YJLW02-64/110 kV 1×400 mm<sup>2</sup>.
3. Cable manufacturer: Jiangsu Baosheng Prysmian Co., Ltd.
4. Number of cable accessories: two groups of cable terminals, respectively located at Huidong

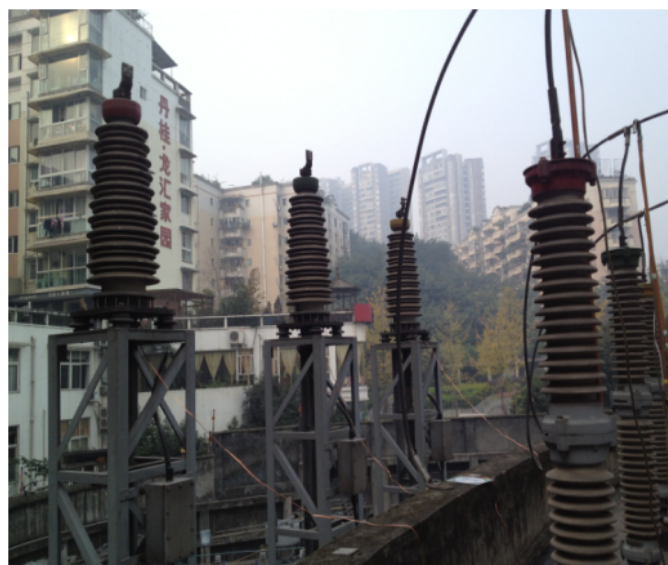
Figure 11: Shuhui Line cable termination, the 122 equipment interval of Huidong Substation

5. Installation of the cable accessories: Changlan Electric Technology Co., Ltd (Changsha Cable Accessories Co., Ltd.).
6. Overall length of the cable: 1,33 km, divided into two sections: the first section was 683 m long (from Huidong Substation to China Mobile); the second section was 650 m long (from China Mobile to the #31 steel pipe pole of Shuhui Line). They are shown in Fig. 11 and Fig. 12.

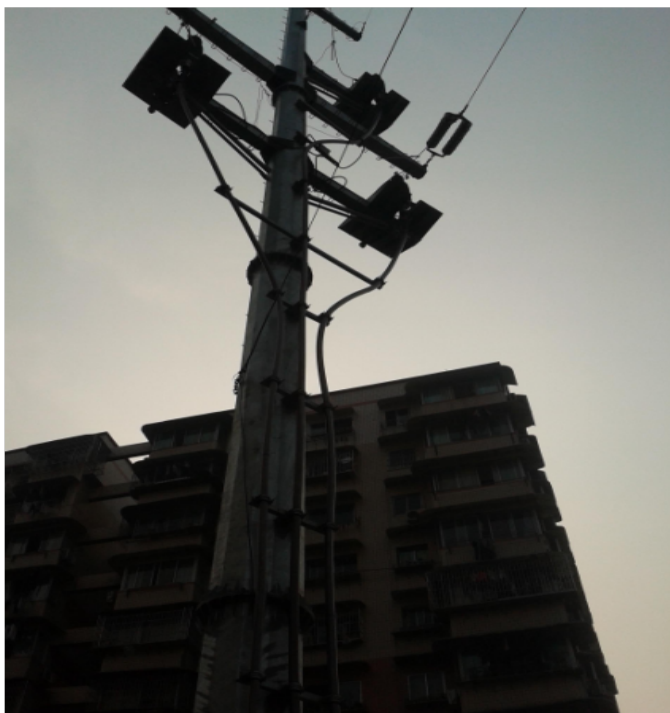
Figure 12: Shuhui Line 110 kV cable termination, pole #31 of Tongda farm produce market

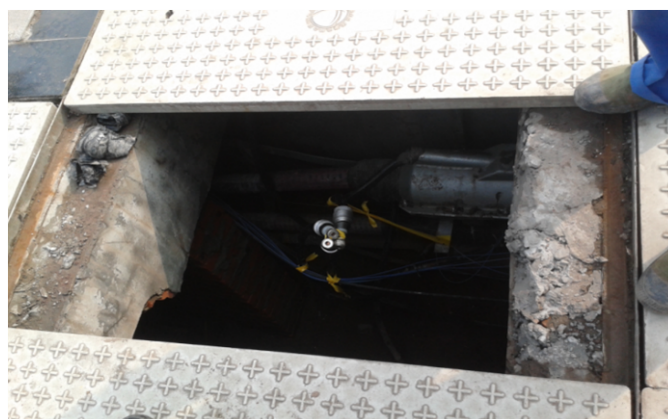
tive layers of Phases A, B and C were all grounded, the metallic layers of the three phases were short circuited and suspended at the cable terminals of China Mobile, with the metallic protective layer of China Mobile as the far end of the voltage method (Fig. 14).

Figure 14: China Mobile was distal, the metallic protective layers were all short circuited and suspended

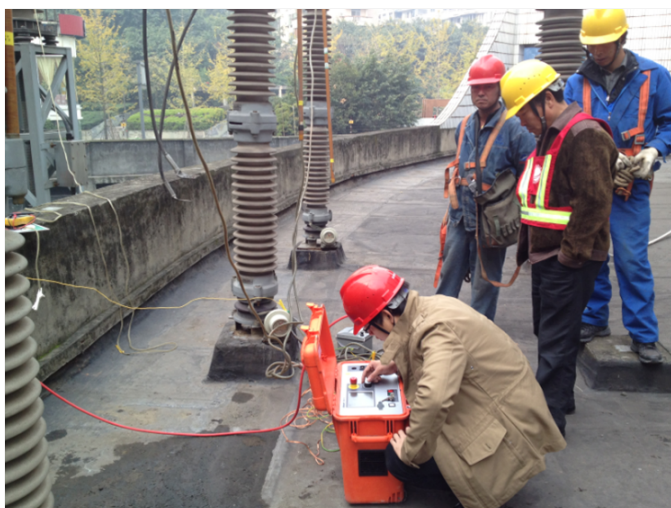
At 11:45 am on 30 November, as shown in Fig. 15, an auxiliary phase voltage method was applied, considering the metallic protective layer of Phase A as the auxiliary phase and ignoring the conductor core of Phase C. Then, MFM10 was connected with the metallic protective layers of Phases A and C. Thus, the overall input length was 1.33 km (683 m + 650 m).

The results of the test conducted at 11:45 am indicated that the outer sheath fault distance was 460 m.

Figure 15: A phase metallic protective layer was the auxiliary phase, MFM10 voltage method predetermining rigid displacement

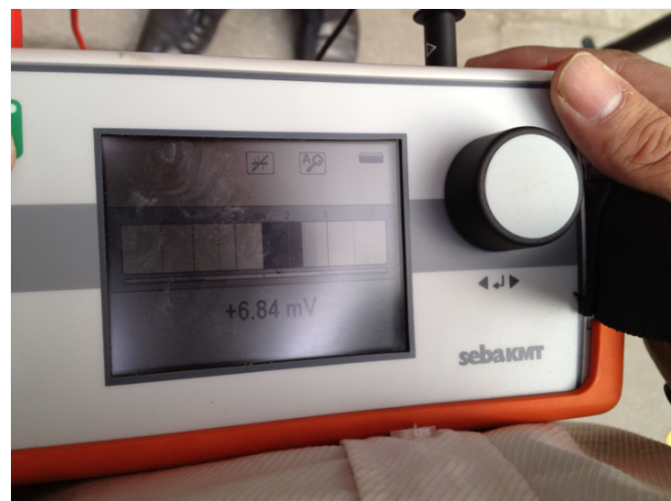
joint of China Mobile), the step voltage value shown on the ESG NT was about 63 mV when it reached the gate of the Zhongxin Teahouse in Zigong City, which is on the opposite side of Lanying Garden and 215 m from China Mobile, and the polarity was reversed. After the ESG NT was moved out of this area, the step voltage value dropped sharply to 0.2 mV or less. The step voltage value increased as the ESG NT was moved closer to the fault, indicating that the cable in that area was faulty. Through further measurement and inspection, the fault was found to be located at the gate of the Zhongxin Teahouse. When checked, it was confirmed that the fault was caused by outer sheath insulation failure (Fig. 18). The test results show that the step voltage method is satis-

Figure 17: Pinpointing the fixed point; the ESG NT automatically displays the step voltage value and direction

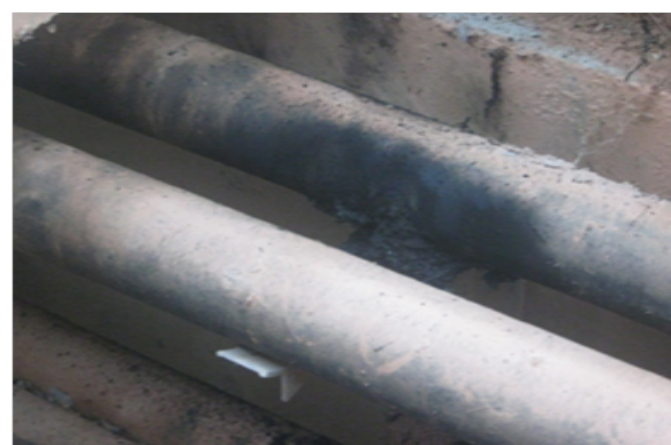
Figure 18: Fault points of single core cable outer sheath layer discolored by heating

1. The outer sheath layer is the outermost layer of the extra-high-voltage cable and serves to segregate the induced voltage of the metallic protective layer, as well as preventing external damage to the cable and the ingress of moisture.
2. If the cable outer sheath to extra-high-voltage cable equipment is neglected for an extended period of time, a significant grounding current will be generated, and much heat will be produced at the damaged point on the outer sheath.

If the heat cannot be radiated away, it will be transferred to the major insulation layer of the cable, melting the cross-linked polyethylene of the cable, which will ultimately result in sudden power failure.

According to the requirement specified in Chapter 5.15 of Regulations of condition-based maintenance & test for electric equipment (Q/GDW168-2008 of China) [16], applying a DC withstand voltage of 5 kV to the metallic protective layer of the extra-high-voltage cable for 1 minute each year is an important means of testing the condition of the outer sheath of the cable. Condition-based maintenance should be carried out on the 110 kV cable of the Shuhui Line according to the Regulations, so
